# ARMORED MEDICAL RESEARCH LABORATORY

PROJECT NO. 44 - PHYSIOLOGICAL AND OPERATIONAL CHARACTERISTICS  
OF M-24 TANK

8 November 1944

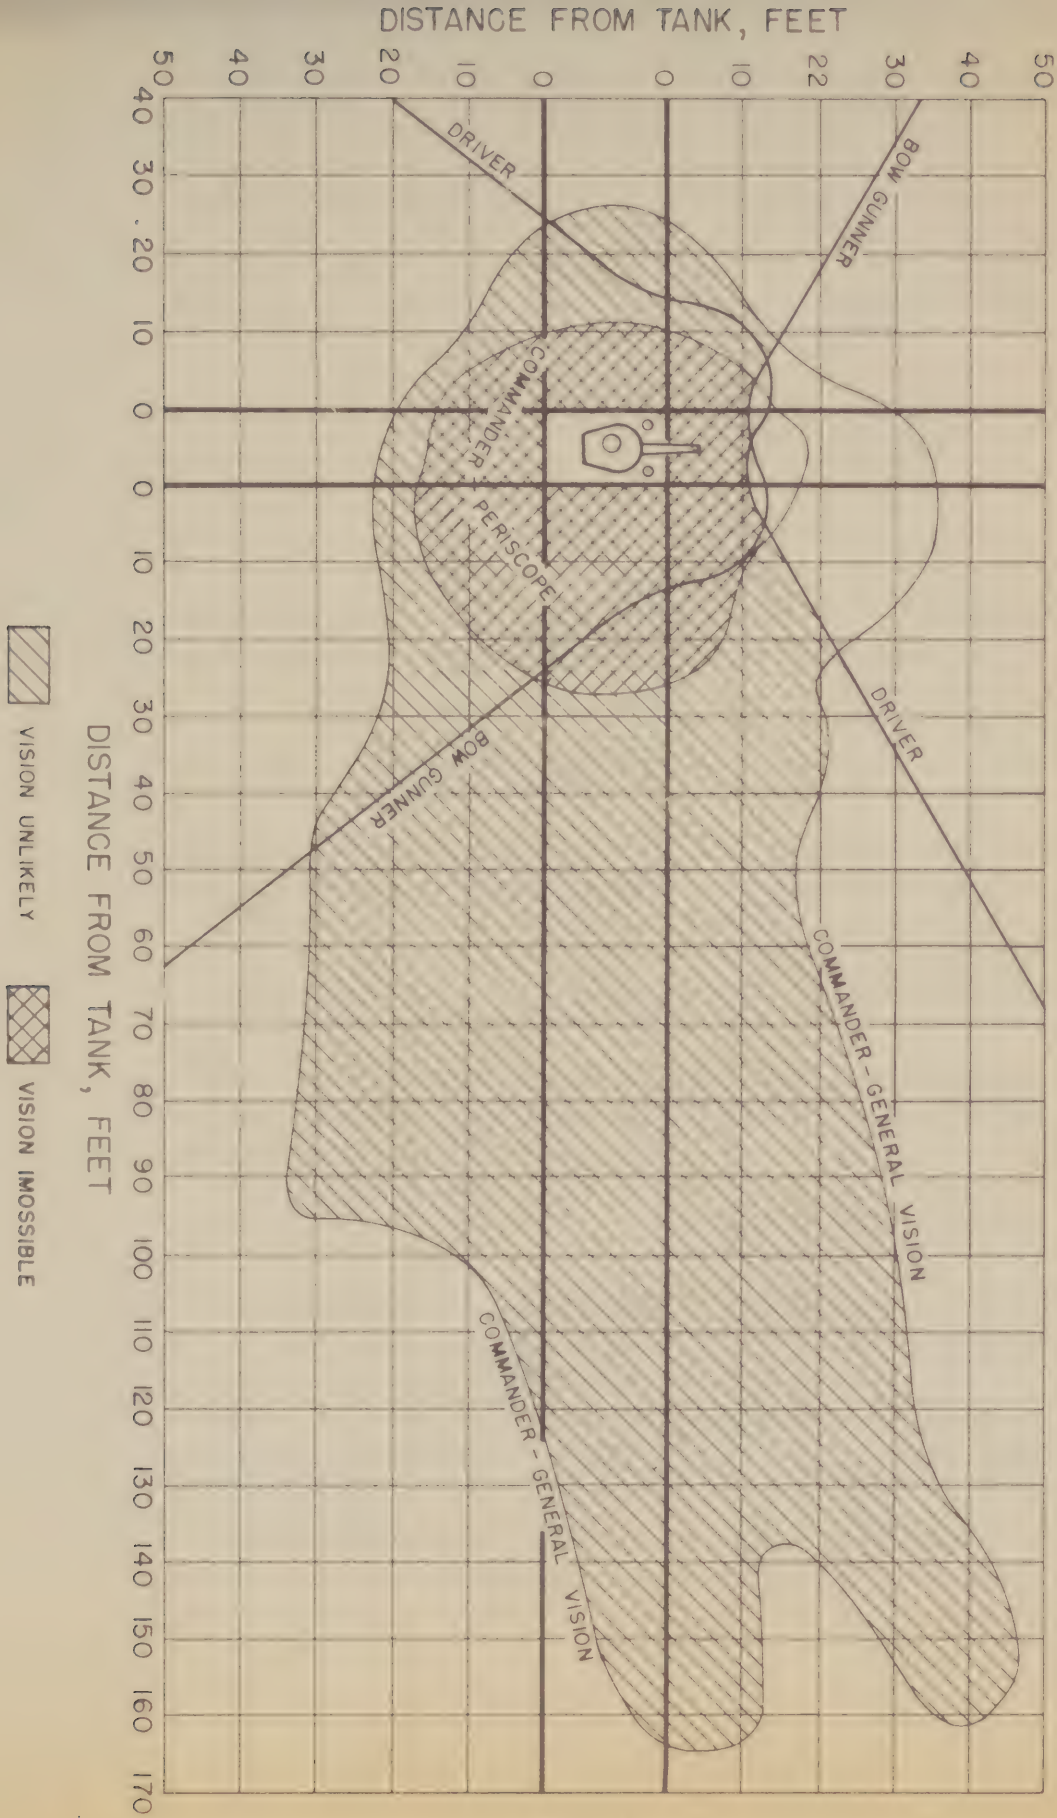
FIG. 1

The overall limits of close-in ground vision from all the various crew positions are shown in Figure 1 and for the driver in more detail in Figure 2. The absence of close-in vision on the right flank and poor vision on the left are serious faults, especially in view of the probable use of this tank in Pacific theatres where protection against ground troops is particularly required. In order to increase the close-in vision, an improved vision cupola for the commander is needed and rhombic vision units to provide vision within 5 feet of the tank should be installed in the right turret wall for use by the loader.

# OVERALL LIMITS OF GROUND VISION ( ALL CREW MEMBERS ) M 24 TANK

c. Immediate consideration be given to the development of an improved vision cupola with less limited ground vision and installation of vision units to provide close ground vision on the loader's side.

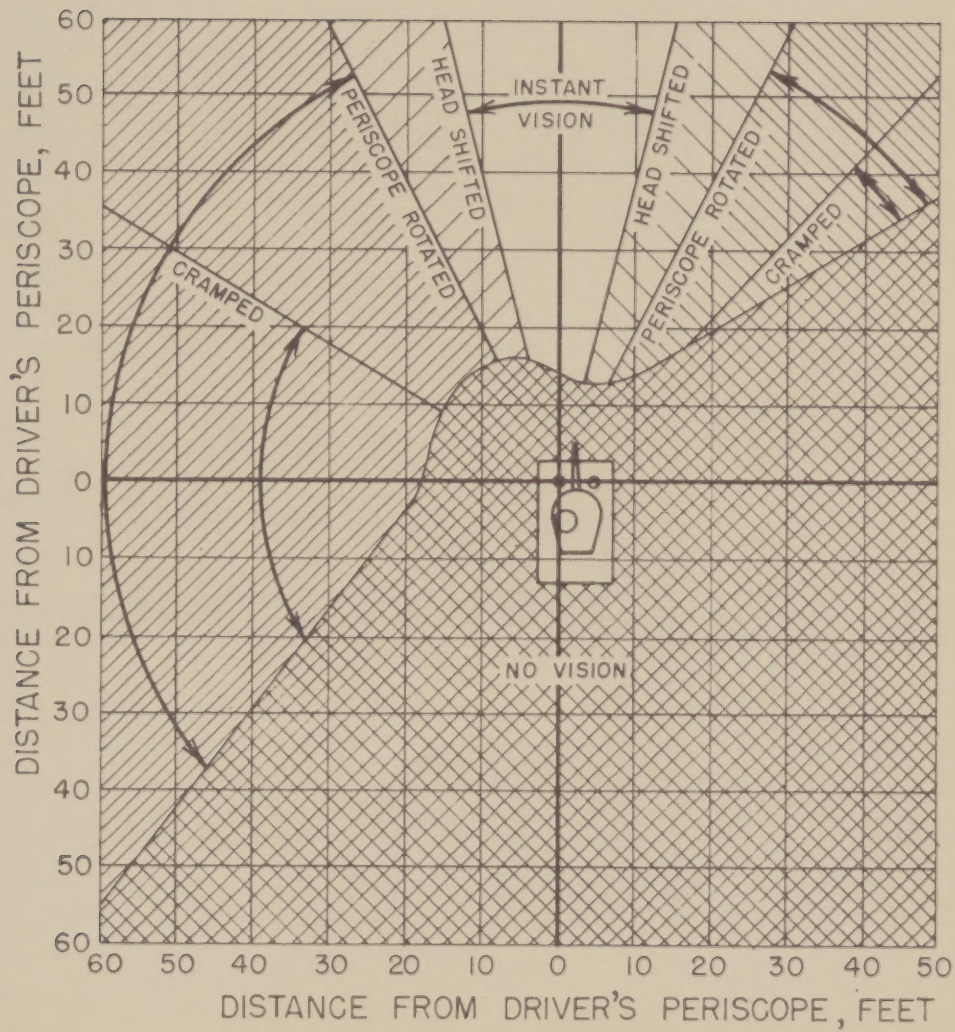
FIG. 2

Driver's vision is limited by the restricted field of view of the present periscope. Wide-field vision units should be provided; for suggested approach to design see AMRL report on Analysis of Physiological Characteristics of T9E1 Tank, dated 27 March 1944 and report on Driver's Vision in Landing Vehicle Tractor, dated 9 March 1944.

The left side of the wind shield holder bracket obstructs the driver's vision in open driving. The bracket should be inclined downward, following the forward sloping contour of the tank.

LIMITS OF DRIVER'S GROUND VISION

d. Immediate consideration be given to improvement of driver's vision.

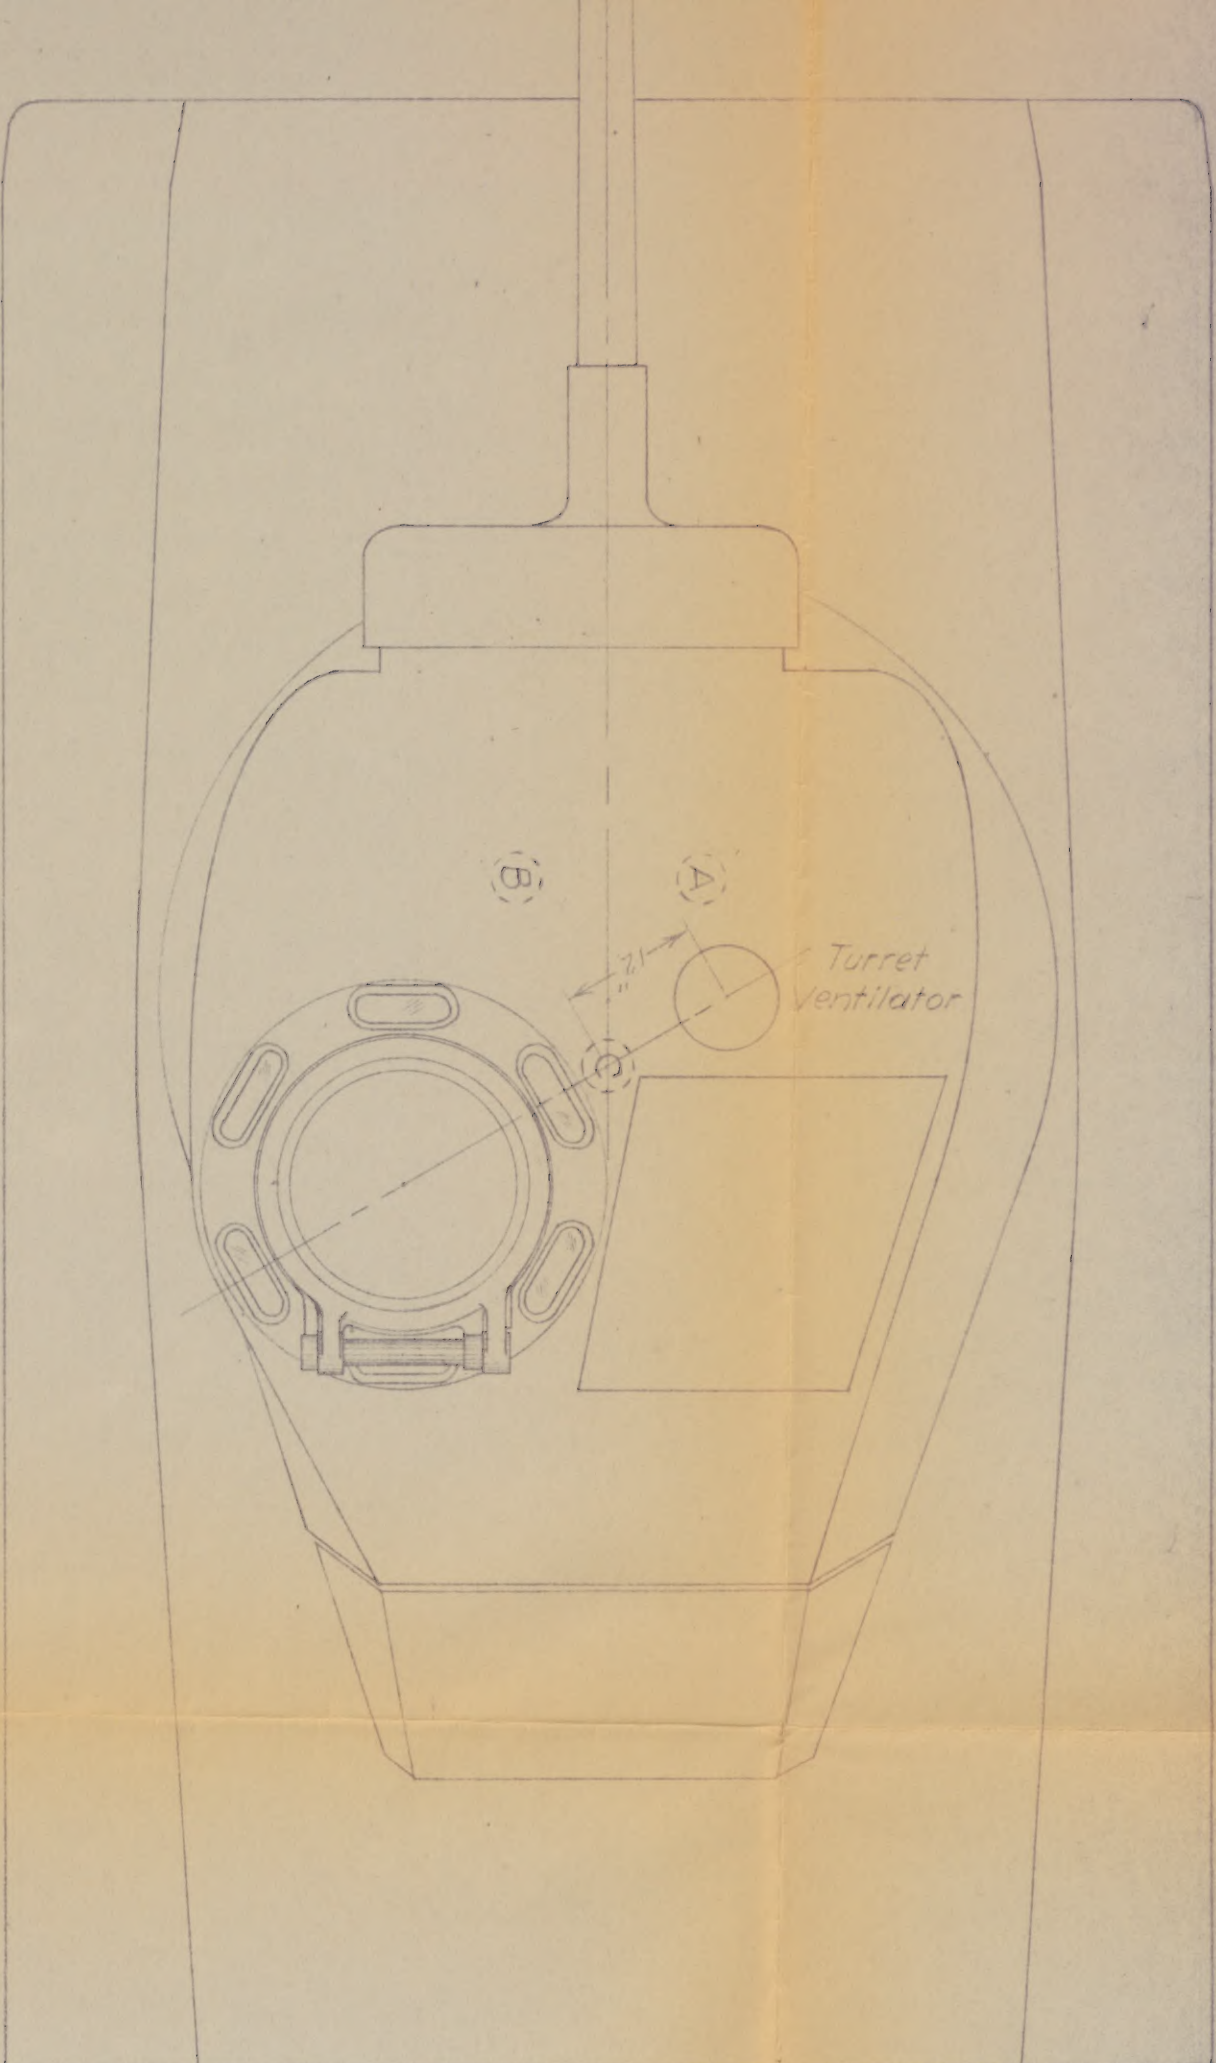
FIG. 3

The present positioning of light fixtures in the turret does not allow sufficient light for the commander for map reading. The left forward turret fixture should be moved from existing position to central location shown in Figure 3. This position also provides more general illumination on main gun breech and radio.

*Fixture A to remain in existing position  
 Fixture B to be moved to position C*

m. Re-locate forward turret light fixture to central position shown in Figure 3.
